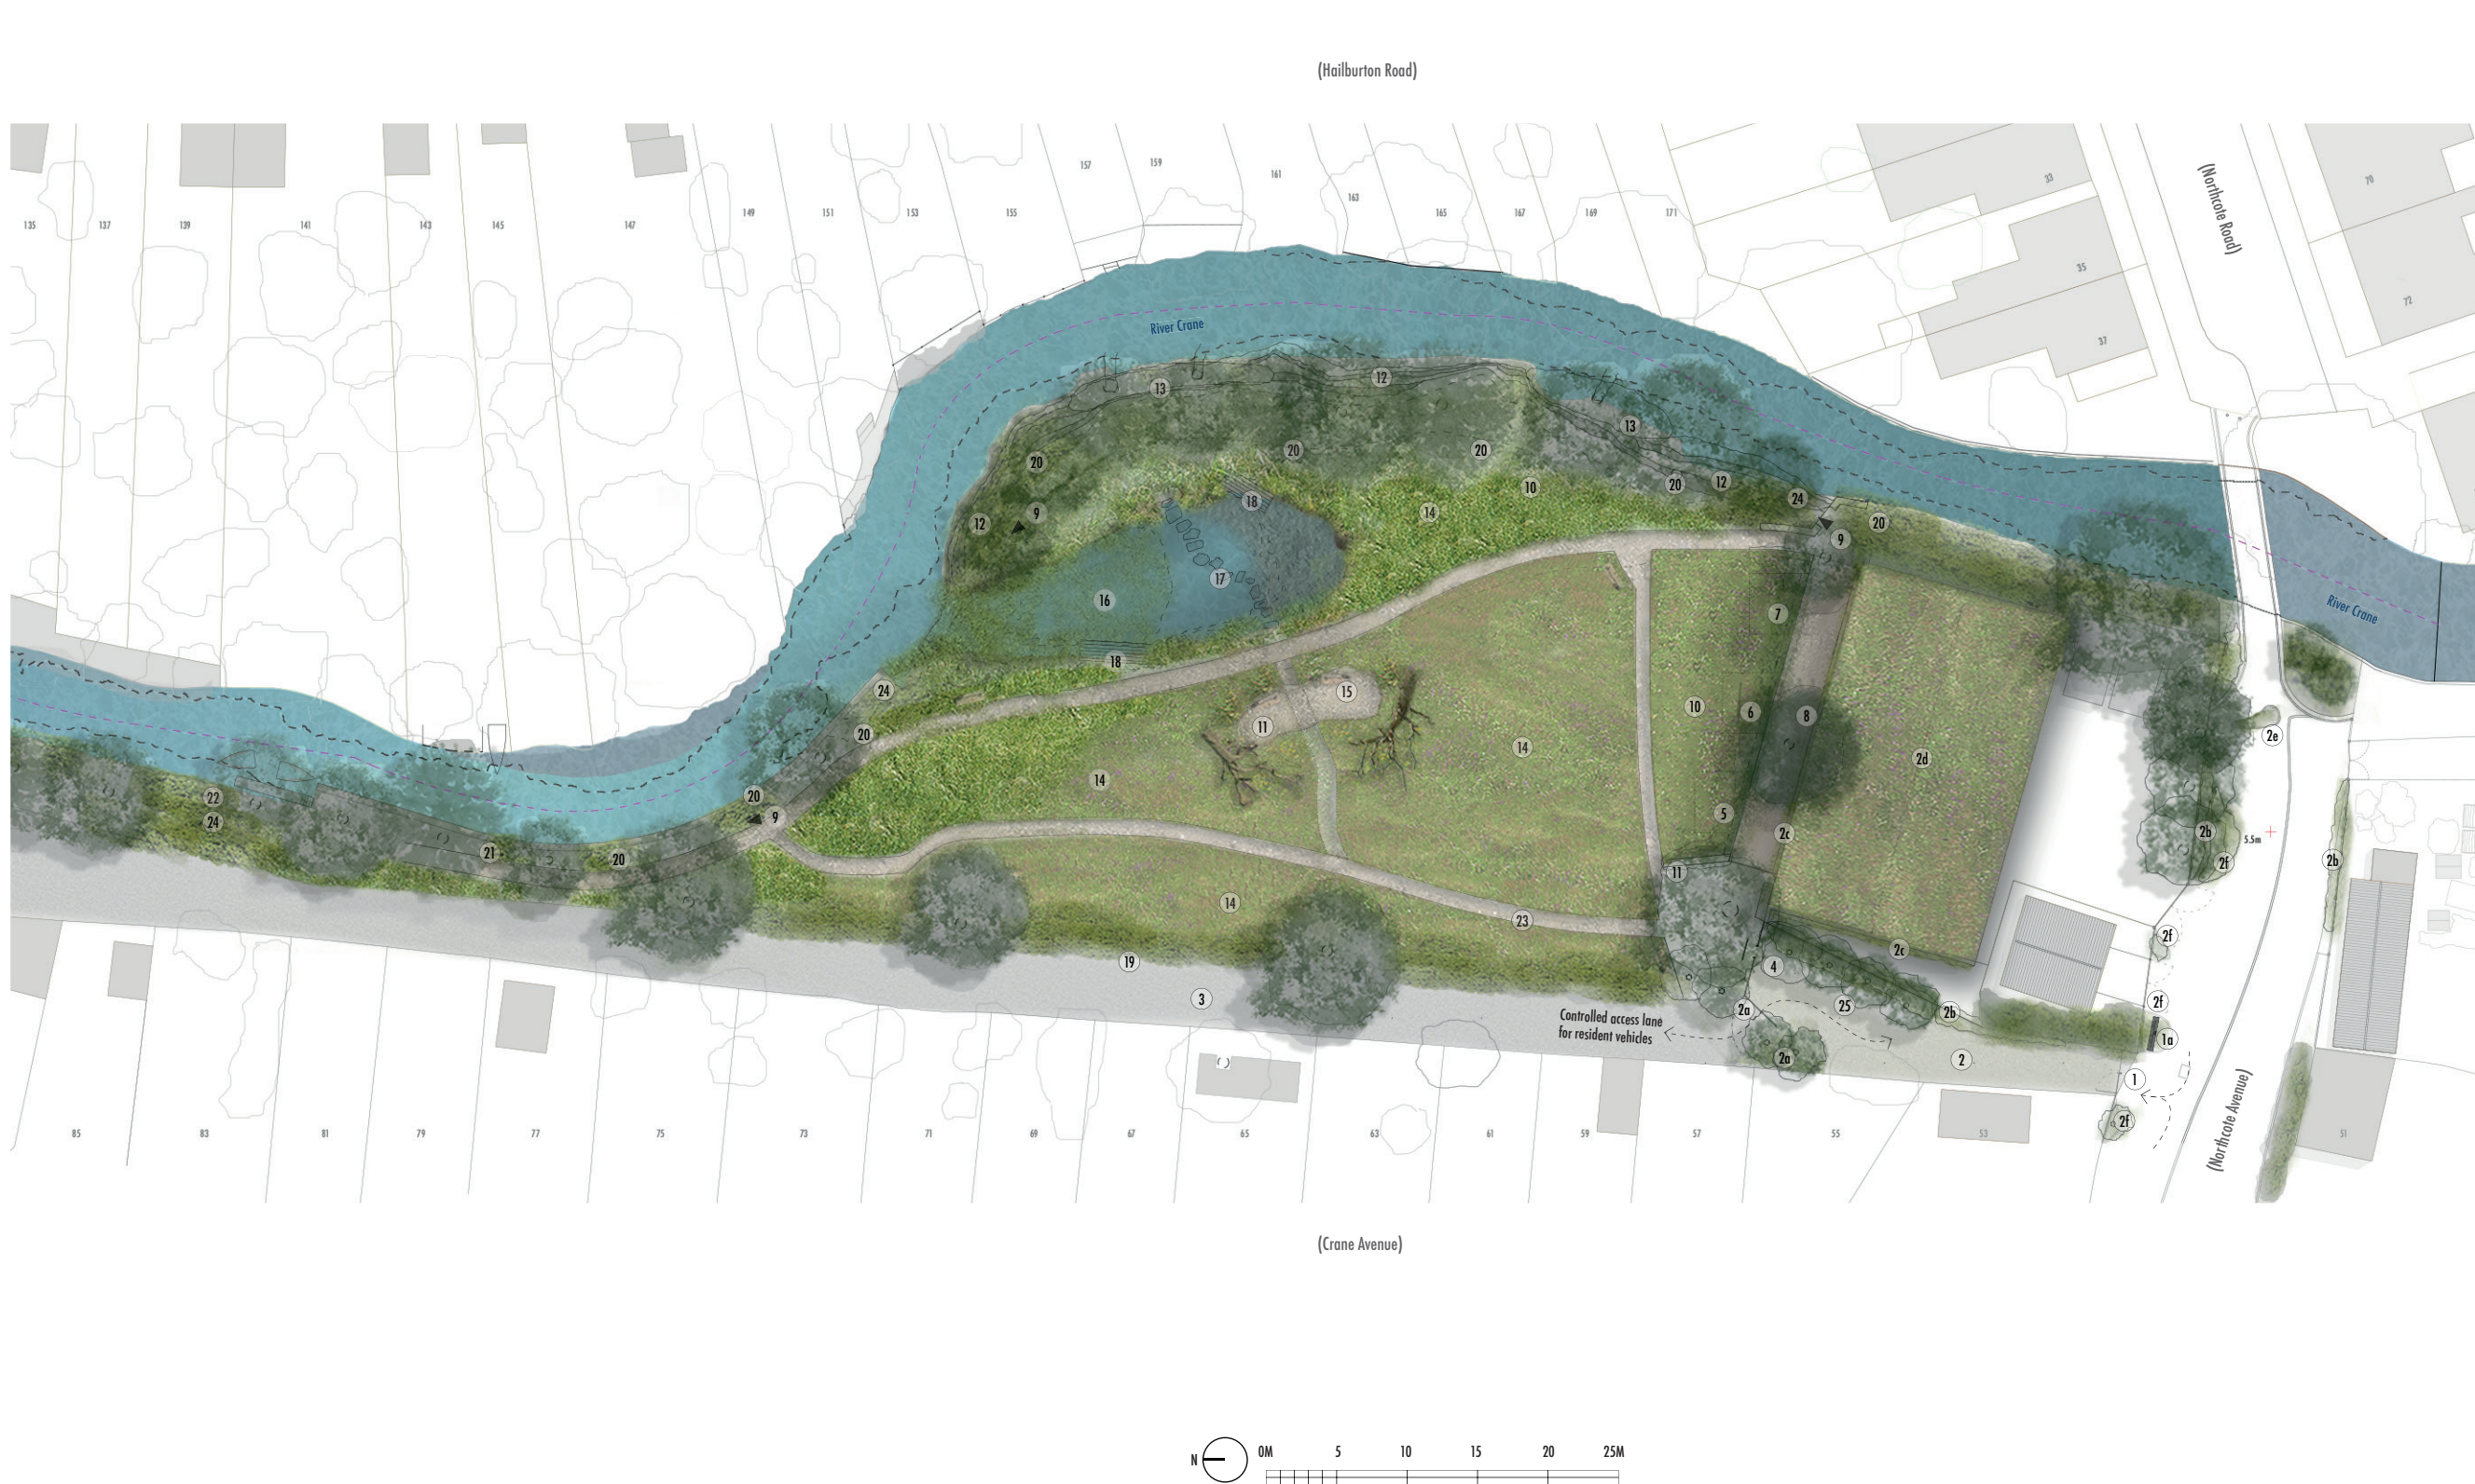
- ① Tall entrance gates
- ①a Interactive signage
- ② Widened gravel entrance track
- ②a Planted island to block sight lines
- ②b Planting / greening of fences

- ②c Greening of walls / living fruit walls / bird and bee habitat
- ②d Greening of roof as extension of wildflower meadow habitat
- ②e Planting island to replace railing

- ②f Increased greening and planting areas within tarmac pavement
- ③ Existing access lane retained
- ③ Controlled access lane gate for resident vehicles

- ④ Staggered gate into reserve, pedestrian access only
- ⑤ Concealed maintenance storage
- ⑥ Concealed bird / wildlife hide
- ⑦ Concealed store for local groups (e.g. Cub Scouts / Brownies)

- ⑧ Educational controlled enclosure for observing and learning about the reserve
- ⑨ Controlled viewpoint along river bank ( not across) ▲
- ⑩ Raised slopes to vary terrain and enclose reserve

- ⑪ Interpretation boards
- ⑫ Terracing along length of northern edge (left bank) to mitigate erosion of bank and create habitat
- ⑬ Tree retained where possible or replaced

- ⑭ Wild flower meadow
- ⑮ Natural seating area with fallen trees
- ⑯ Backwater inlet and refuge, and reeded tidal water habitat
- ⑰ Stepping stones
- ⑱ Timber decks around inlet

- ⑲ Fence removed and hedge introduced along length of lane
- ⑳ Perimeter thicket habitat and natural screening of large scale planting/ trees / brushes along full length of northern edge ( left bank)  
N.B. Fence retained and absorbed/substituted within thicket over time

- ㉑ Controlled / fence access to mooring (no other access to river)
- ㉒ Mooring posts
- ㉓ Gravel path ( wheelchair accessible)
- ㉔ Life-ring
- ㉕ Orchard and controlled market garden
